Recent Tevatron Operations + Last Week's Failure in D3

Ron Moore

Fermilab – Tevatron Dept.

Component Failure in D3

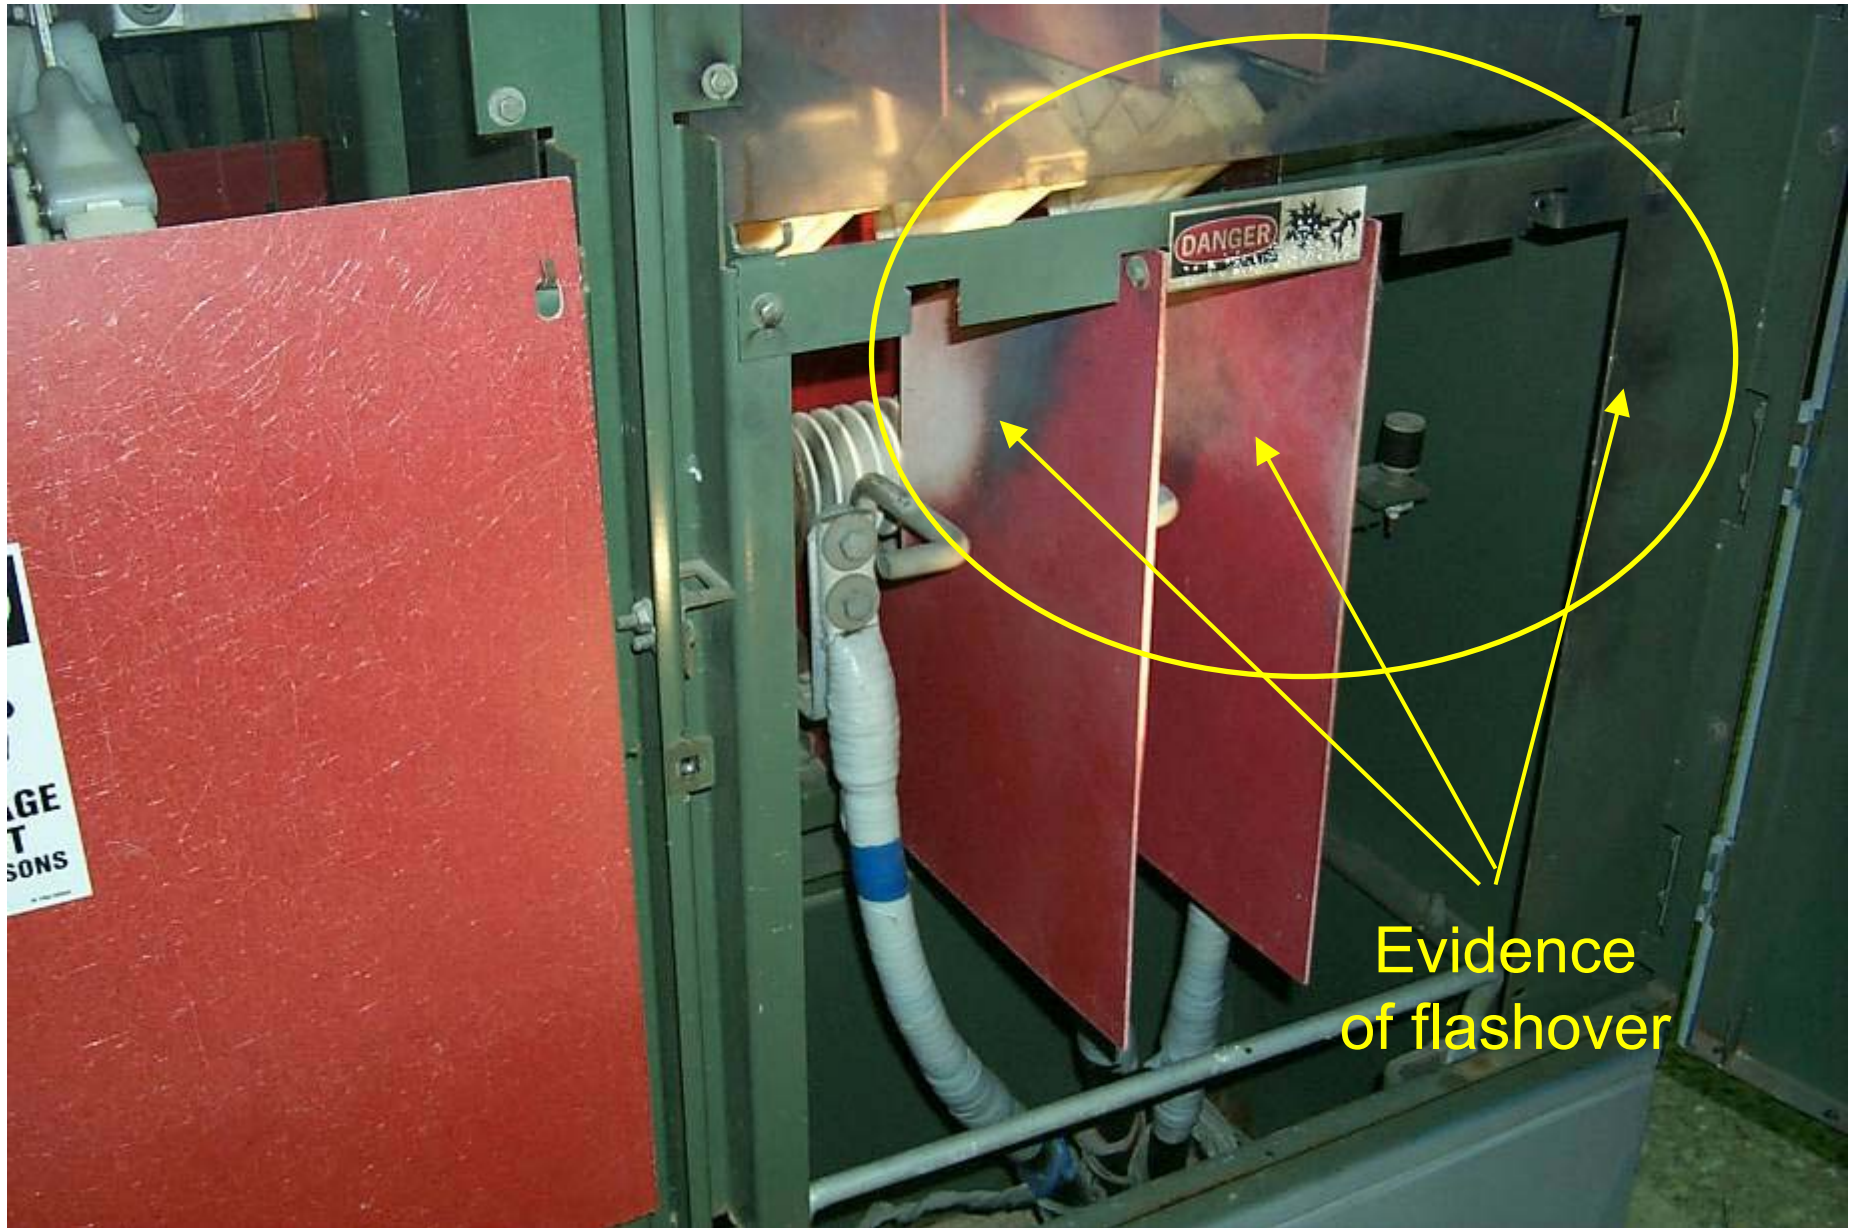
Feeder 46B Cubicle near D0

- HEP store 5008 happily spinning
 - Record # pbars injected into Tev, record # pbars reach HEP start
- Mouse seeks Feeder 46B cubicle as possible new, cozy home
 - Flashover + resulting nasty power glitch affects many systems
 - Many UPS units switched over
- Tevatron ramp begins to dump on A2 power supply trip
 - Beams aborted cleanly
- 1.2 sec into ramp dump, D3 QPM reboots (Quench Protection Monitor)
 - Why? Glitch not filtered out by UPS? UPS tested fine later...
 - As designed, QPM fired heaters, generating whole-house quench
- ≈ 4 sec into ramp dump, ground fault developed in D3
 - D32-5 dipole failed

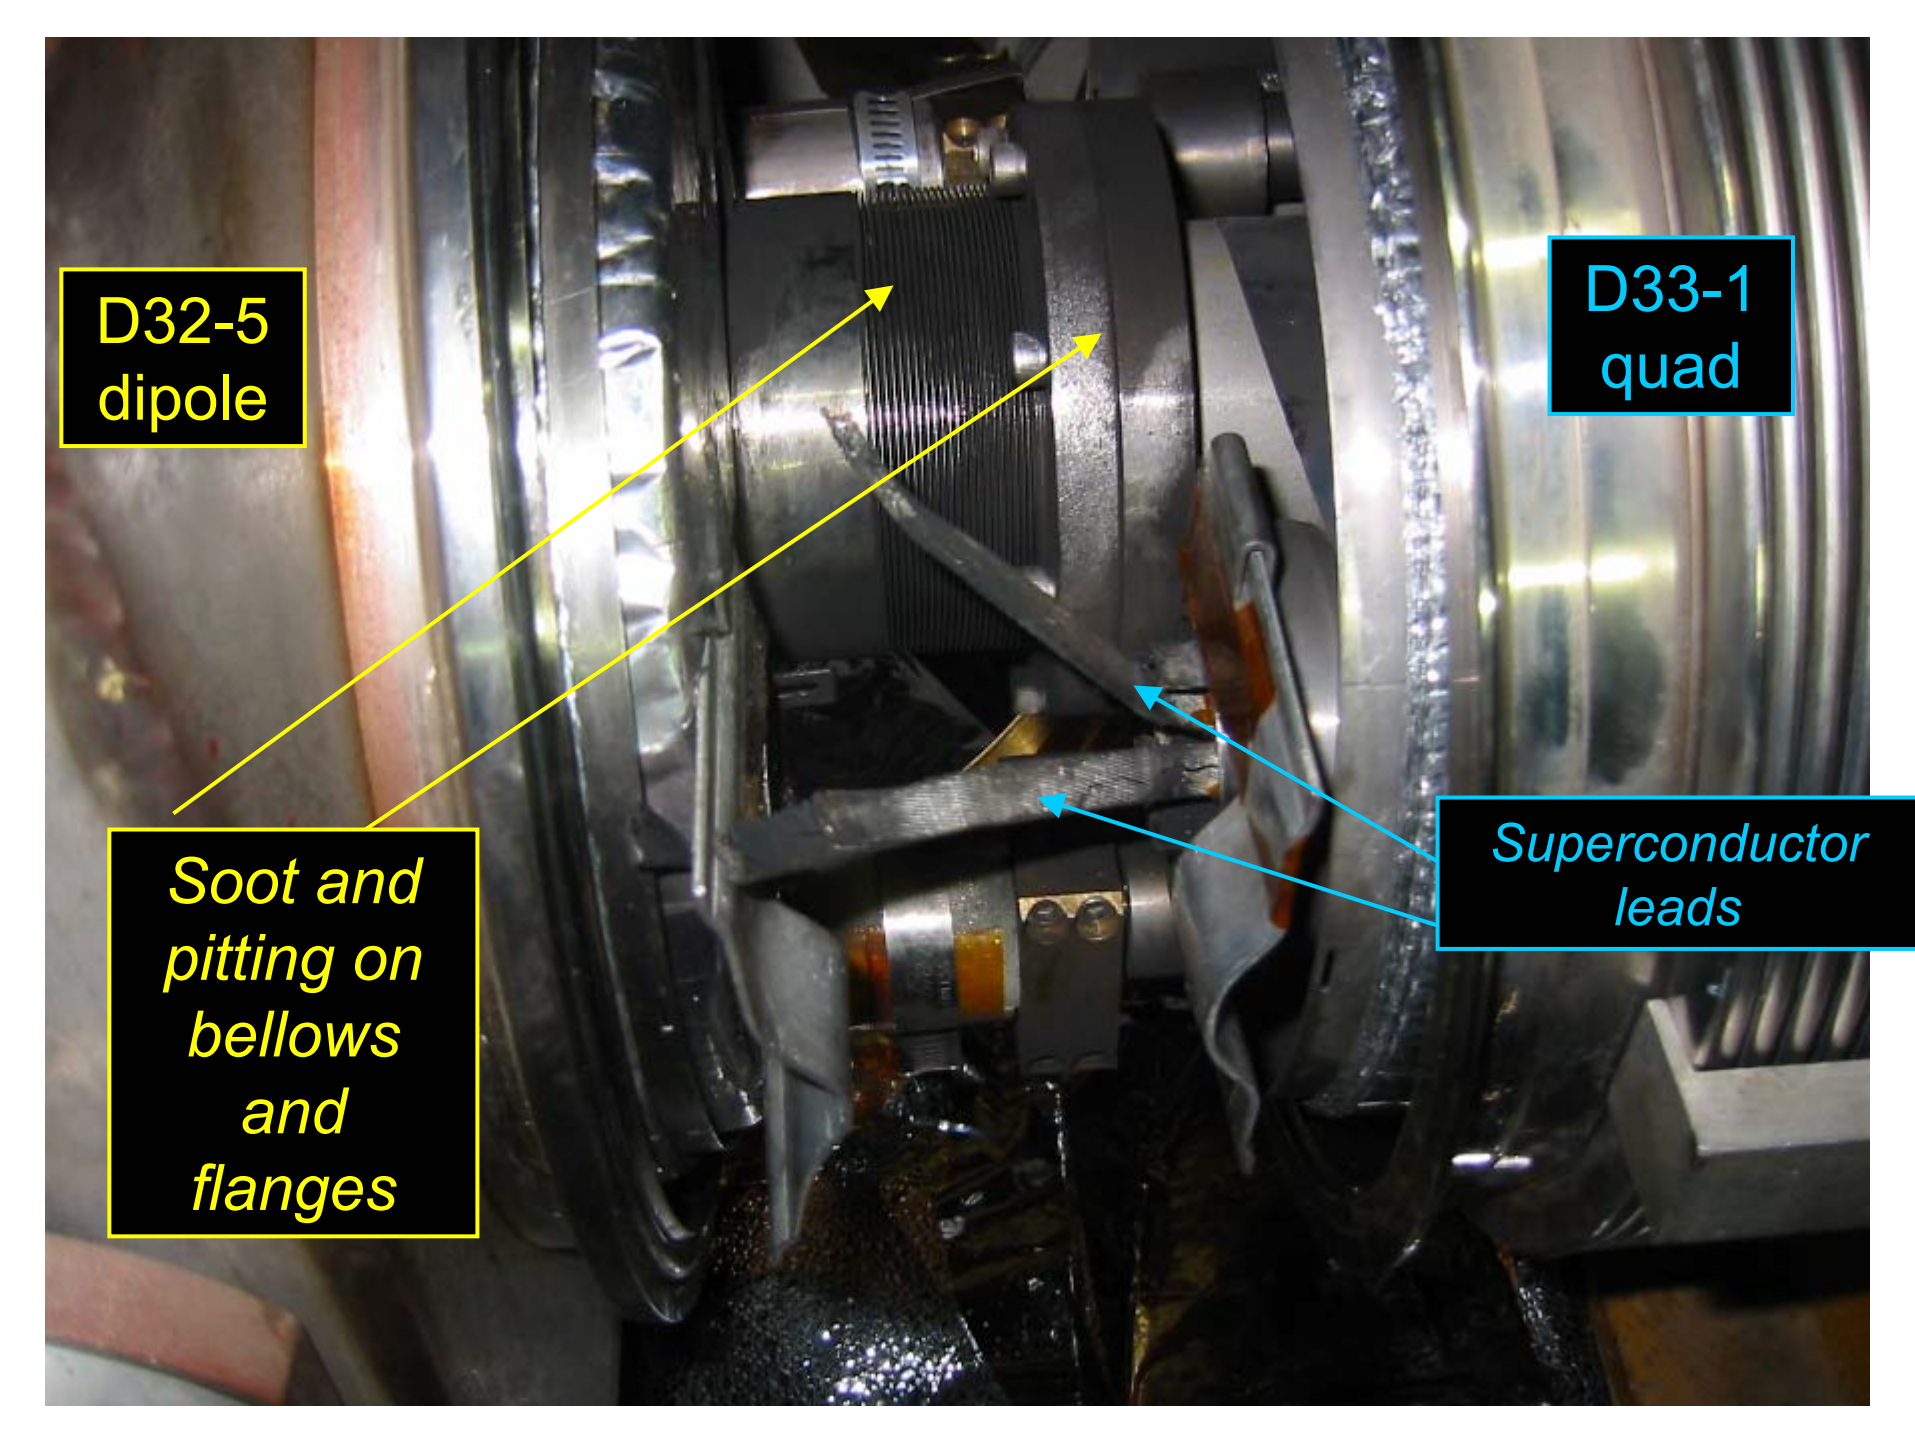
*Soot and
pitting on
bellows
and
flanges*

*Superconductor
leads*

- Why that failure now? Speculate that a problem was lurking there...
 - Mechanical stresses from this quench enough to cause failure
 - D3 quenches infrequent – last one was Sep 11, 2002
- What is being replaced?
 - D32-5 dipole and D33-1 quadrupole
 - D35 spool package (broken dipole corrector, unrelated to this failure)
- Helium and “soot” in beam tube
 - Sucked into beam pipe from single phase line after arc-through
 - Leaky isolation valves between adjacent sectors...D1-D2-D3-D4
 - Complicated vacuum recovery
 - Swabbed out $\geq 10(?)$ magnets – required moving into aisle
 - Concern about separators
 - RGA scans show plenty of helium, but little carbon or hydrocarbons
 - More optimistic now, still want to power them up soon to check
 - Will need time for conditioning, can be done during cool-down

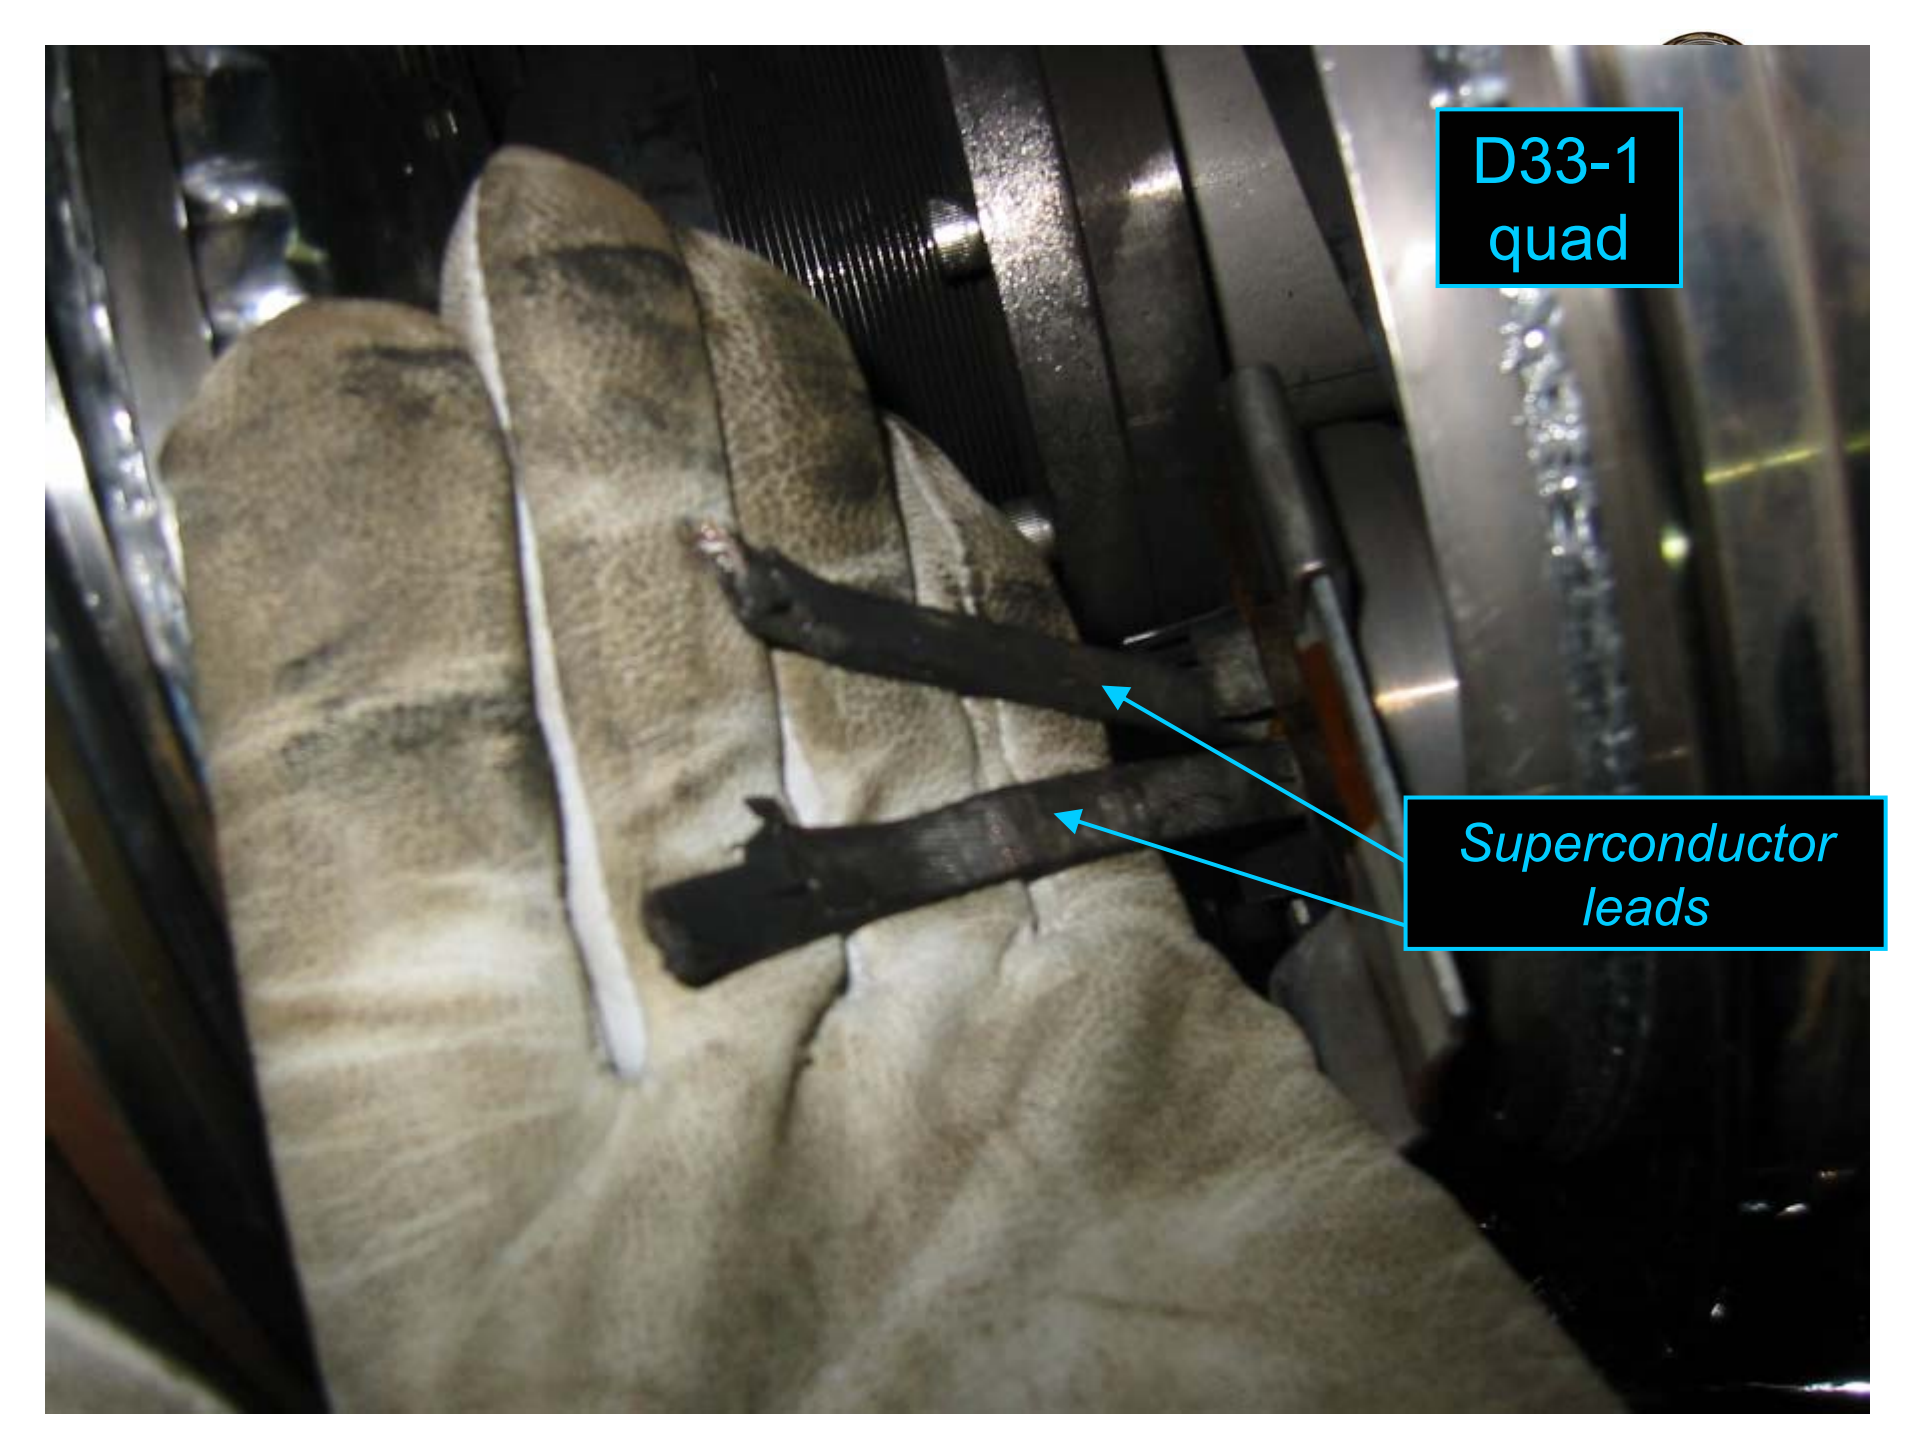
D33-1
quad

*Superconductor
leads*

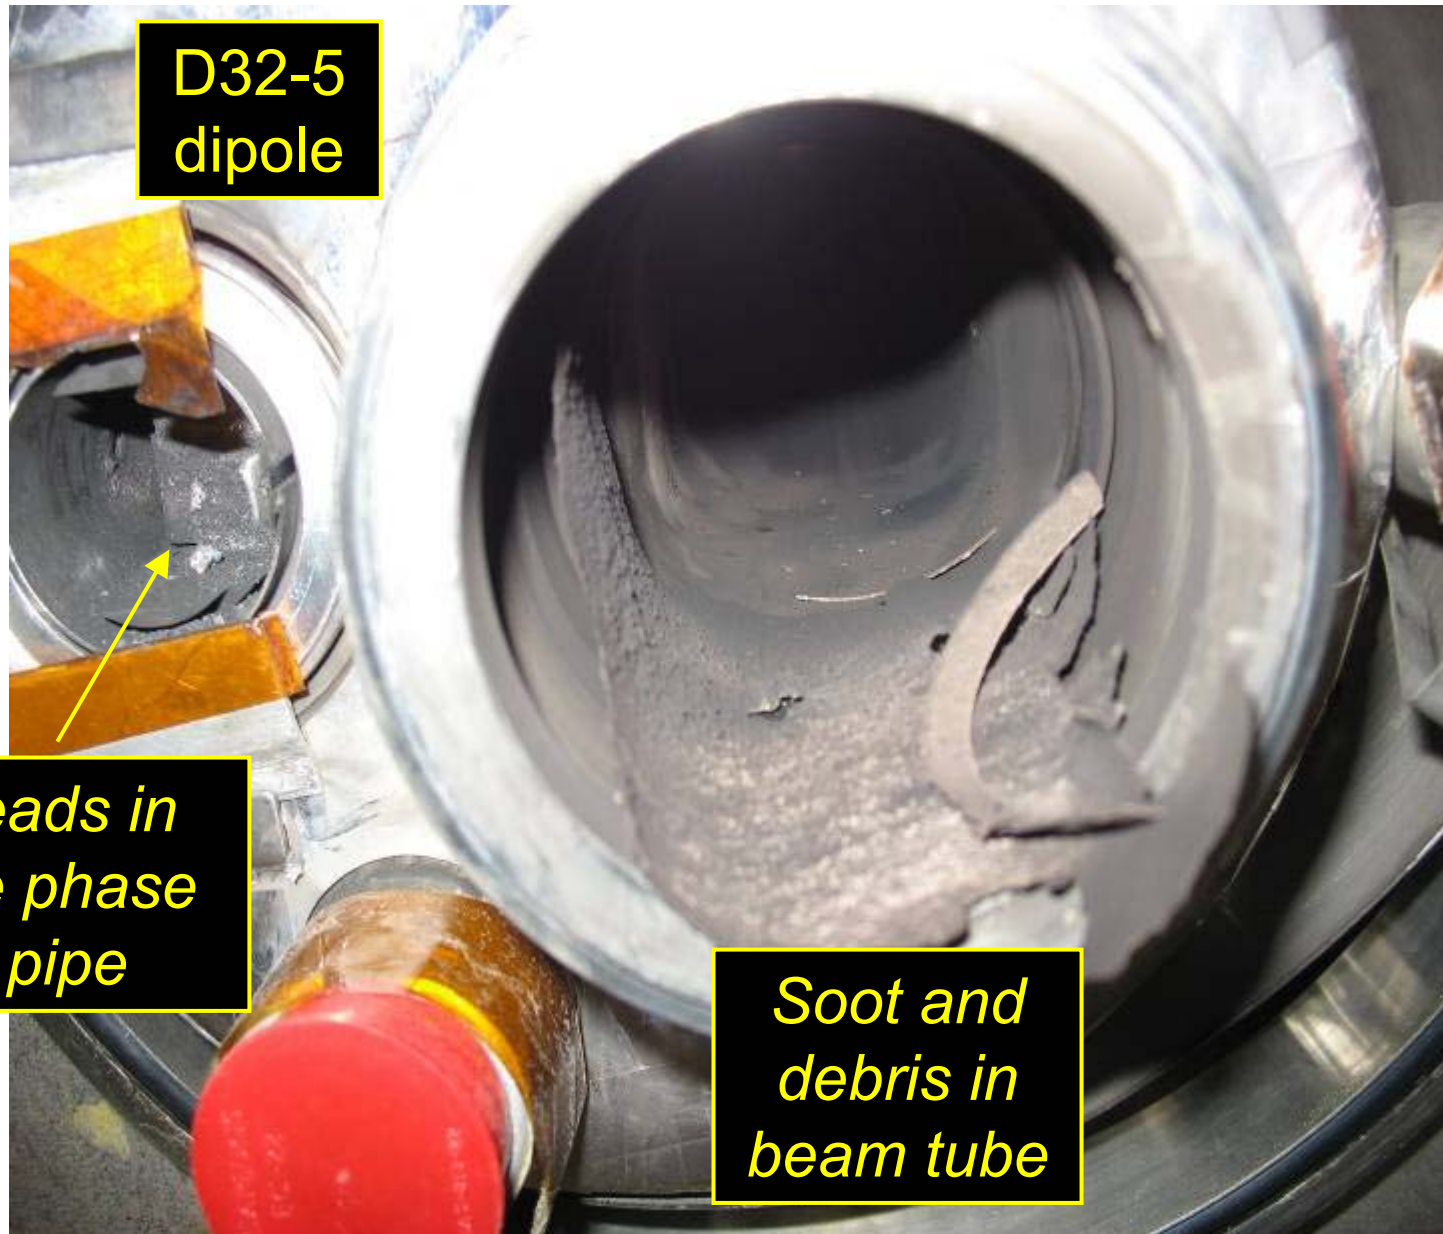
D32-5
dipole

*No leads in
single phase
He pipe*

*Soot and
debris in
beam tube*

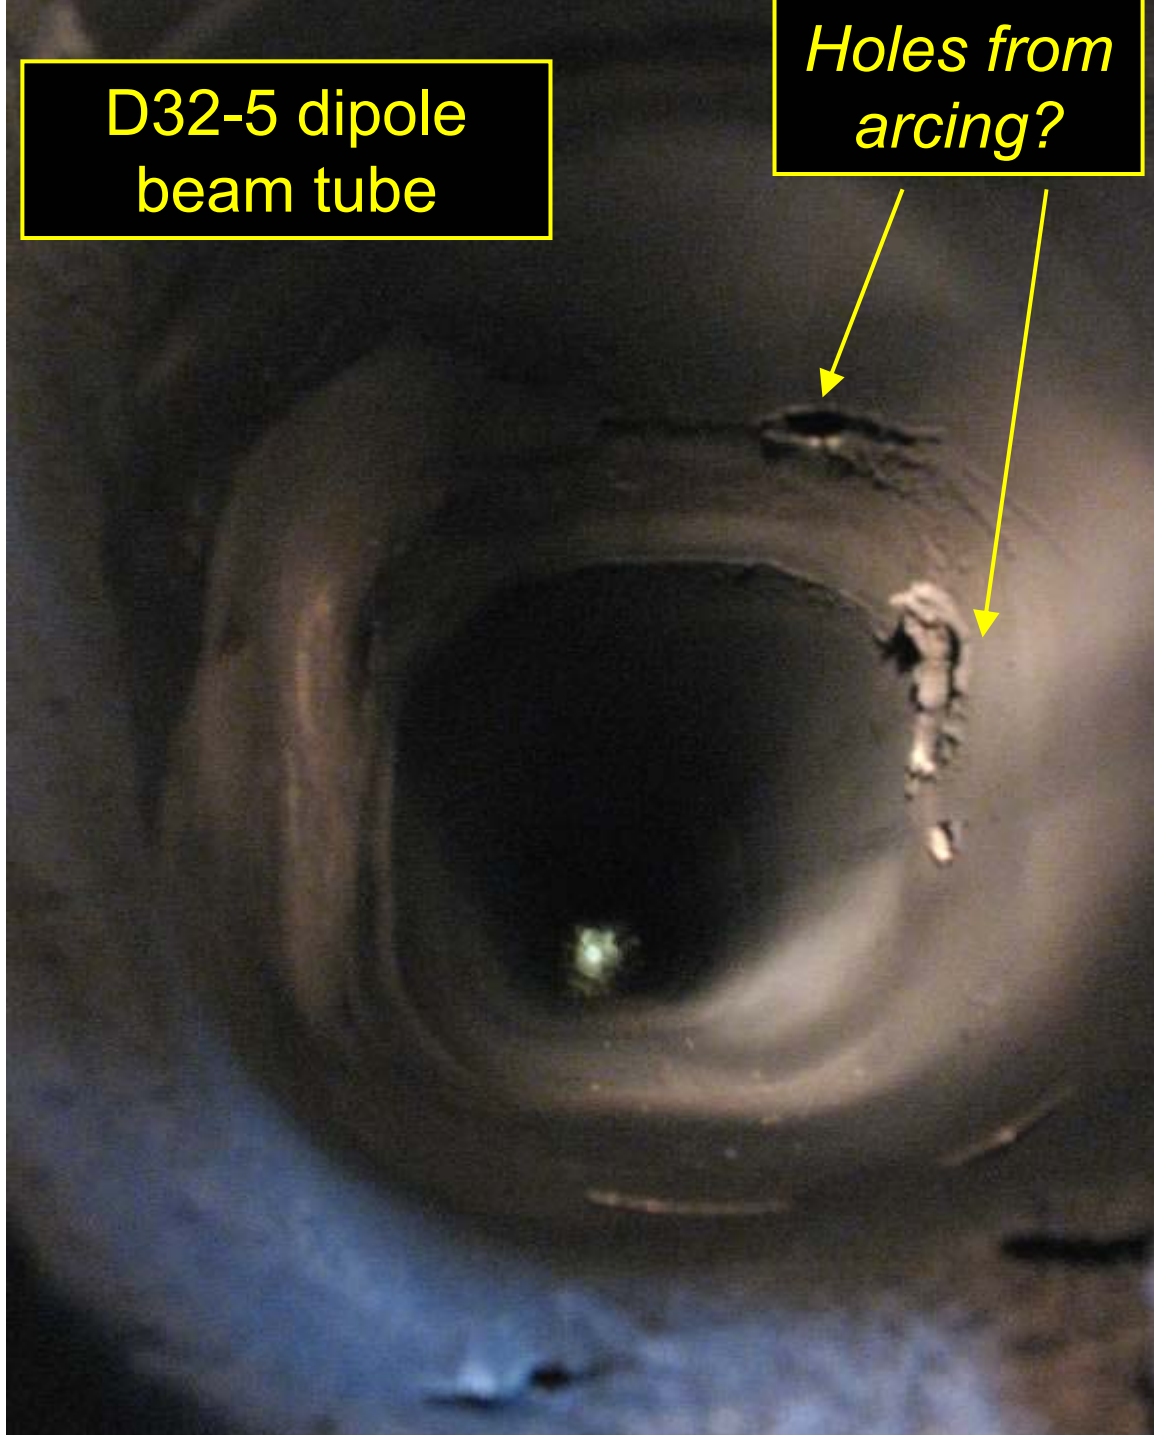
D32-5 dipole
beam tube

*Holes from
arcing?*
